# **Navajo Abandoned Uranium Mine**

## **Site Screen Report**

### **Enos Johnson AUM Site**

#### **Navajo AUM Northern Region**

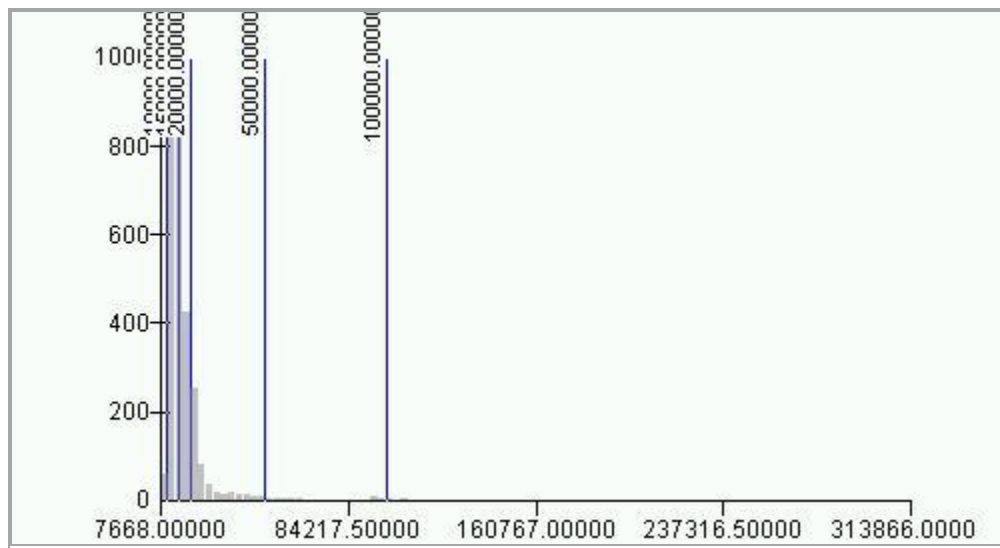
The following chart and statistics were generated by ESRI ArcGIS 9.3.1, and show the general distribution of the site gamma radiation measurements. The horizontal X axis represents the gamma radiation reading levels in cpm (lowest levels to the left). The vertical Y axis represents the frequency of each gamma radiation level.

Count:	2878
Minimum:	7668.00000
Maximum:	313866.00000
Sum:	53883985.00000
Mean:	18722.71890
Median:	15403.00000
Standard Deviation:	18147.35158

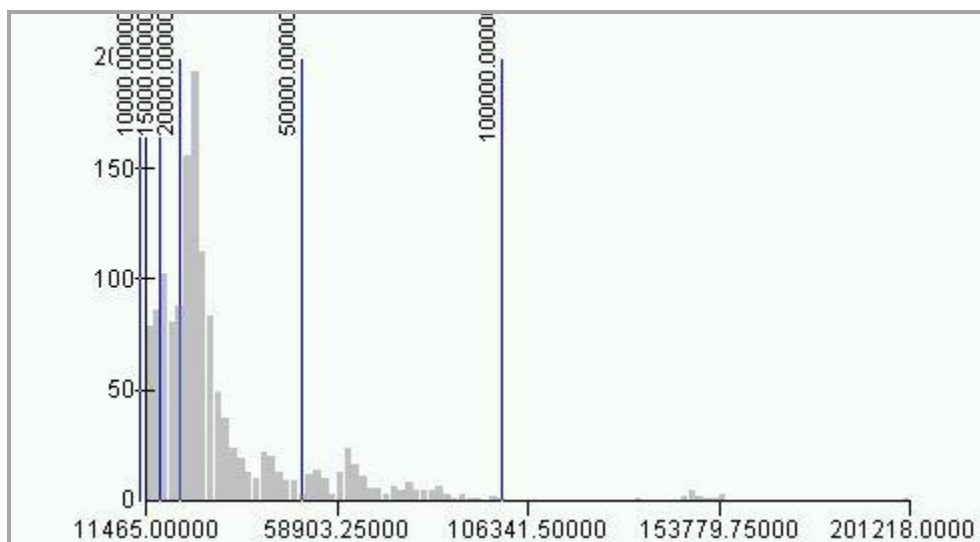
The following chart and statistics were generated by ESRI ArcGIS 9.3.1, and show the general distribution of the site gamma radiation measurements. The horizontal X axis represents the gamma radiation reading levels in cpm (lowest levels to the left). The vertical Y axis represents the frequency of each gamma radiation level.

Count:	1383
Minimum:	11465.00000
Maximum:	201218.00000
Sum:	41692491.00000
Mean:	30146.41432
Median:	23684.00000
Standard Deviation:	20630.36538

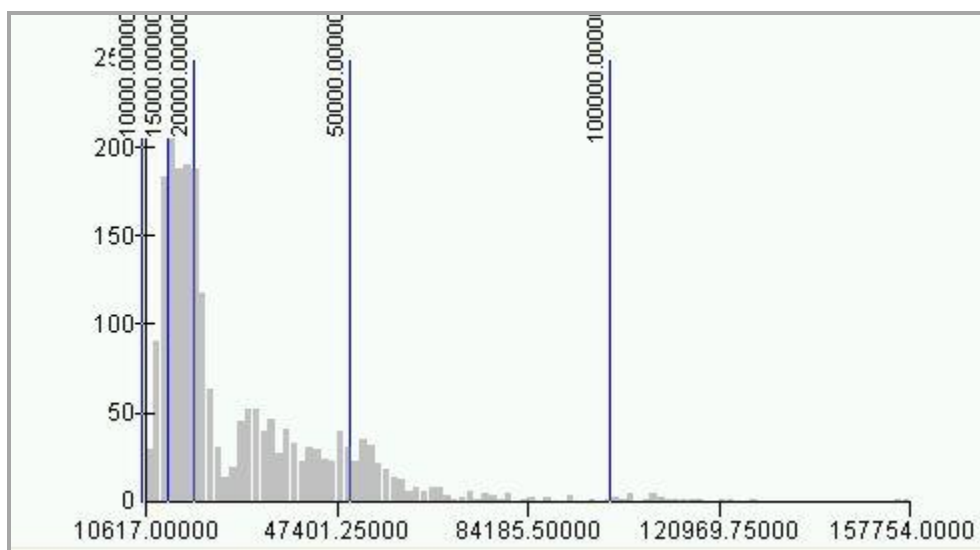
The following chart and statistics were generated by ESRI ArcGIS 9.3.1, and show the general distribution of the site gamma radiation measurements. The horizontal X axis represents the gamma radiation reading levels in cpm (lowest levels to the left). The vertical Y axis represents the frequency of each gamma radiation level.

Count:	2120
Minimum:	10617.00000
Maximum:	157754.00000
Sum:	60318896.00000
Mean:	28452.30943
Median:	20594.50000
Standard Deviation:	17673.07343

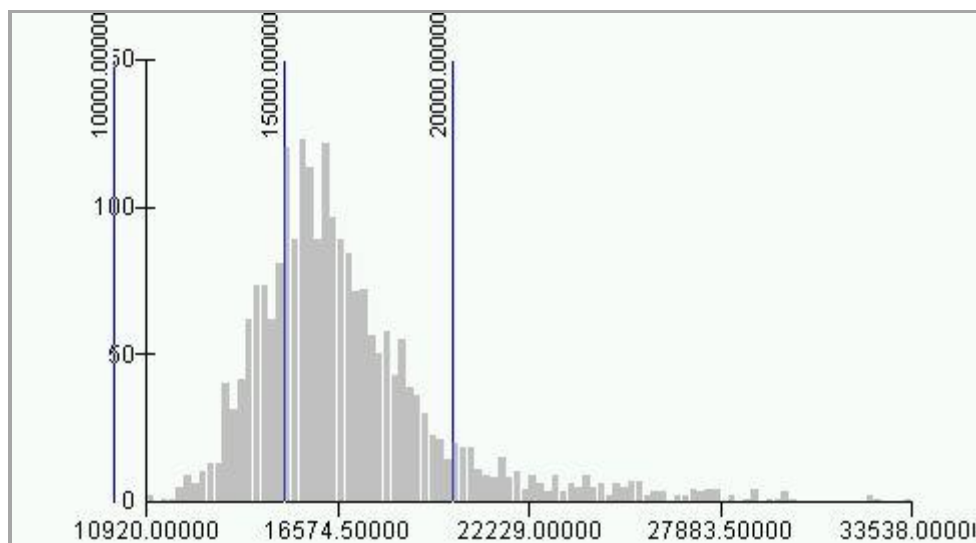
The following chart and statistics were generated by ESRI ArcGIS 9.3.1, and show the general distribution of the site gamma radiation measurements. The horizontal X axis represents the gamma radiation reading levels in cpm (lowest levels to the left). The vertical Y axis represents the frequency of each gamma radiation level.

Count:	2267
Minimum:	10920.00000
Maximum:	33538.00000
Sum:	38248027.00000
Mean:	16871.64843
Median:	16269.00000
Standard Deviation:	2892.37215

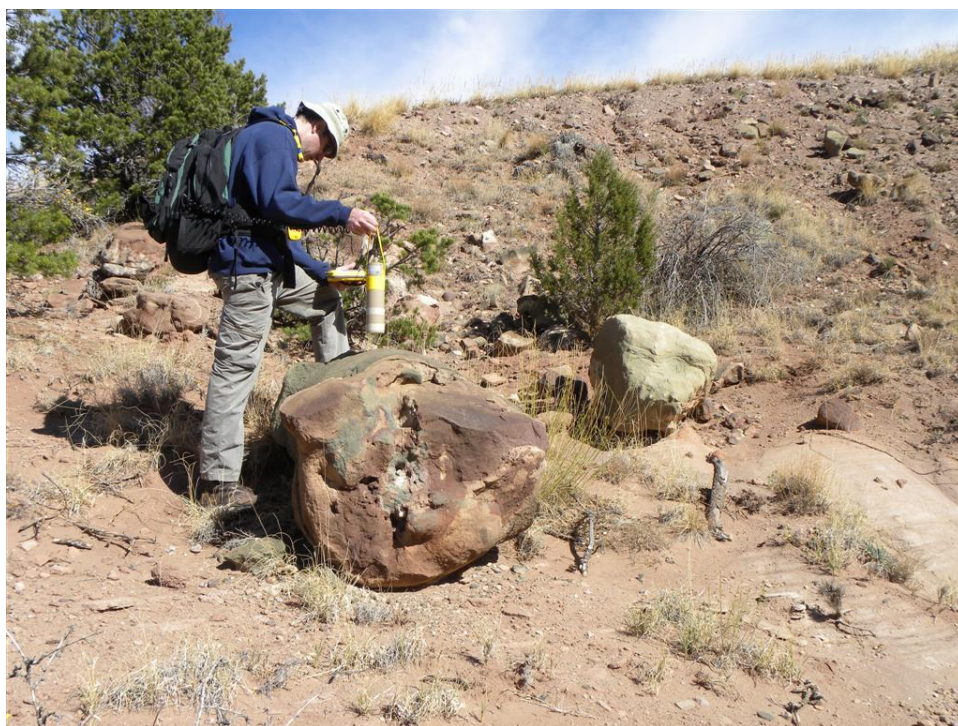
A total of 1,383 gamma radiation measurements were collected from the mine site, ranging from 11,465 cpm to 201,218 cpm. Measurements in the vicinity of the waste debris with exposed green boulders, near the rim strip were found at levels ranging from 50,000 - 150,000 cpm. The measurements are represented in Figures 4 and 5.

Some slough off from existing rim strip operation leading into site with exposed green boulders; reclamation cap found in the center of the site

Photo 4. Mine site #465 exposed green rock with elevated readings

Waste debris found at sites #465 and #466; reclamation cap at site #465

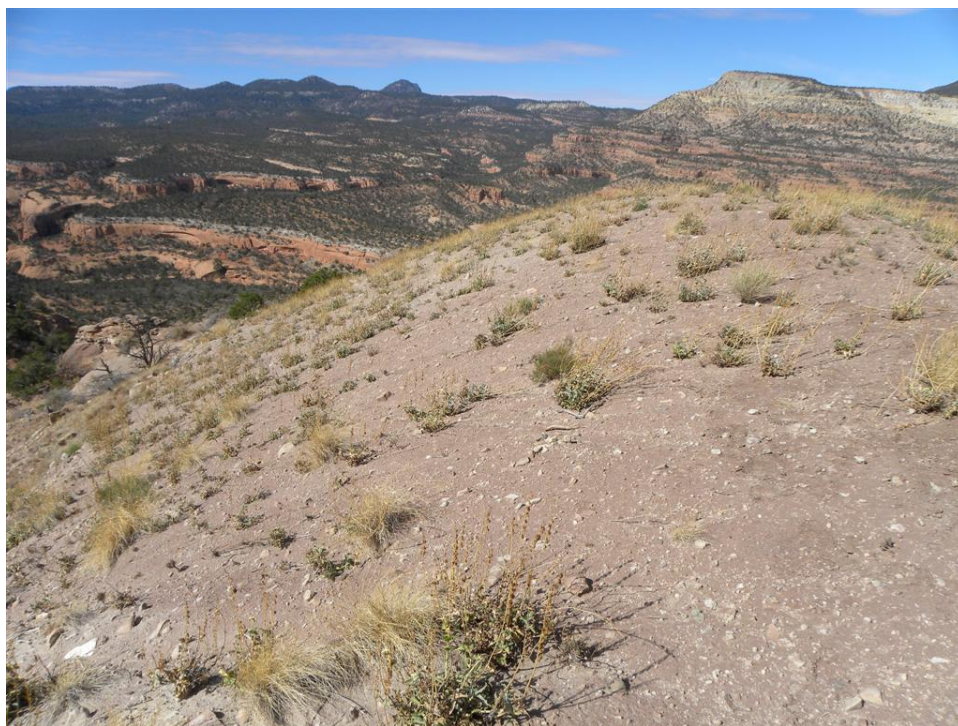
Photo 5. Mine site #465 reclamation cap

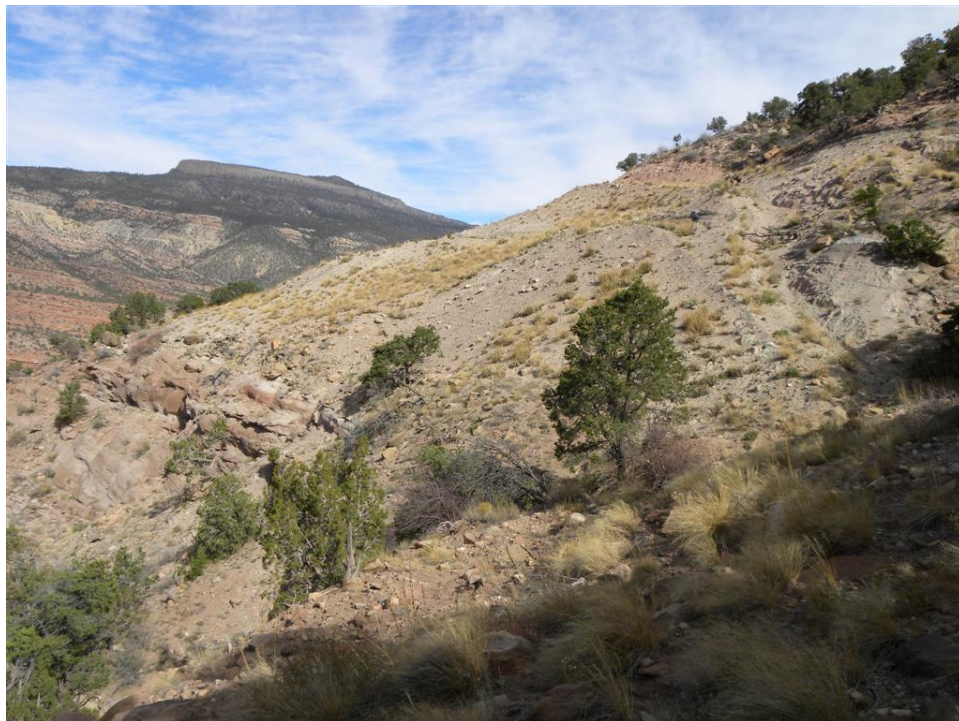
A total of 2,120 gamma radiation measurements were collected from the mine site, ranging from 10,617 cpm to 157,754 cpm. Measurements in the vicinity of the waste debris slope were found at levels above 100,000 cpm. The measurements are represented in Figures 6 and 7.

Debris slope with salt wash member, 100' x 250', with a total estimated volume of 4,630 yd<sup>3</sup>

Photo 7. Mine site #466 waste debris

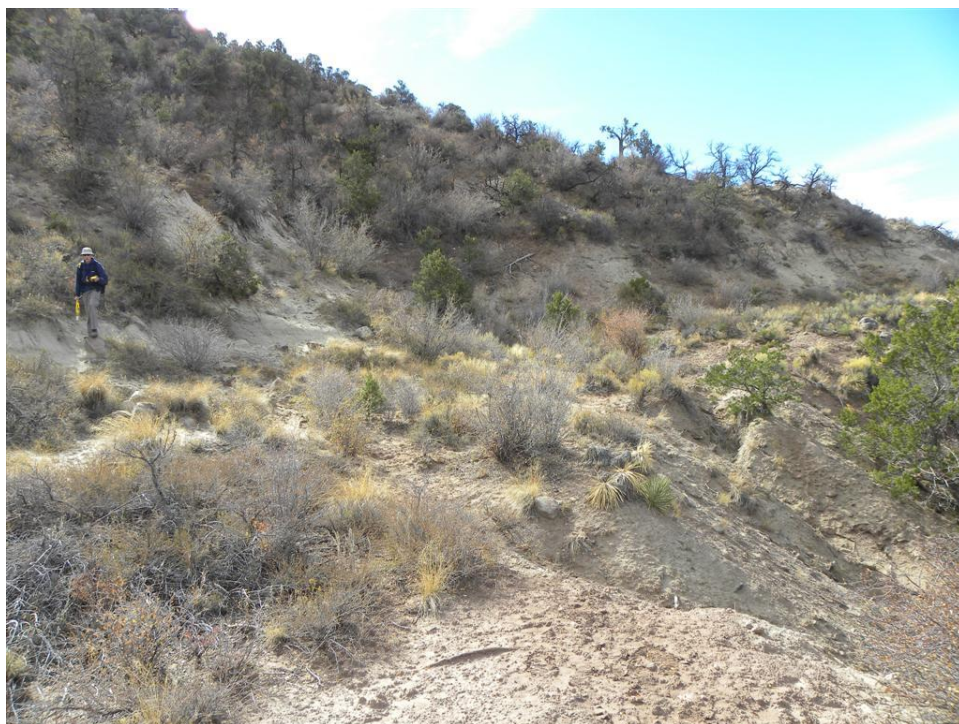
Photo 8. Mine site #466 waste debris

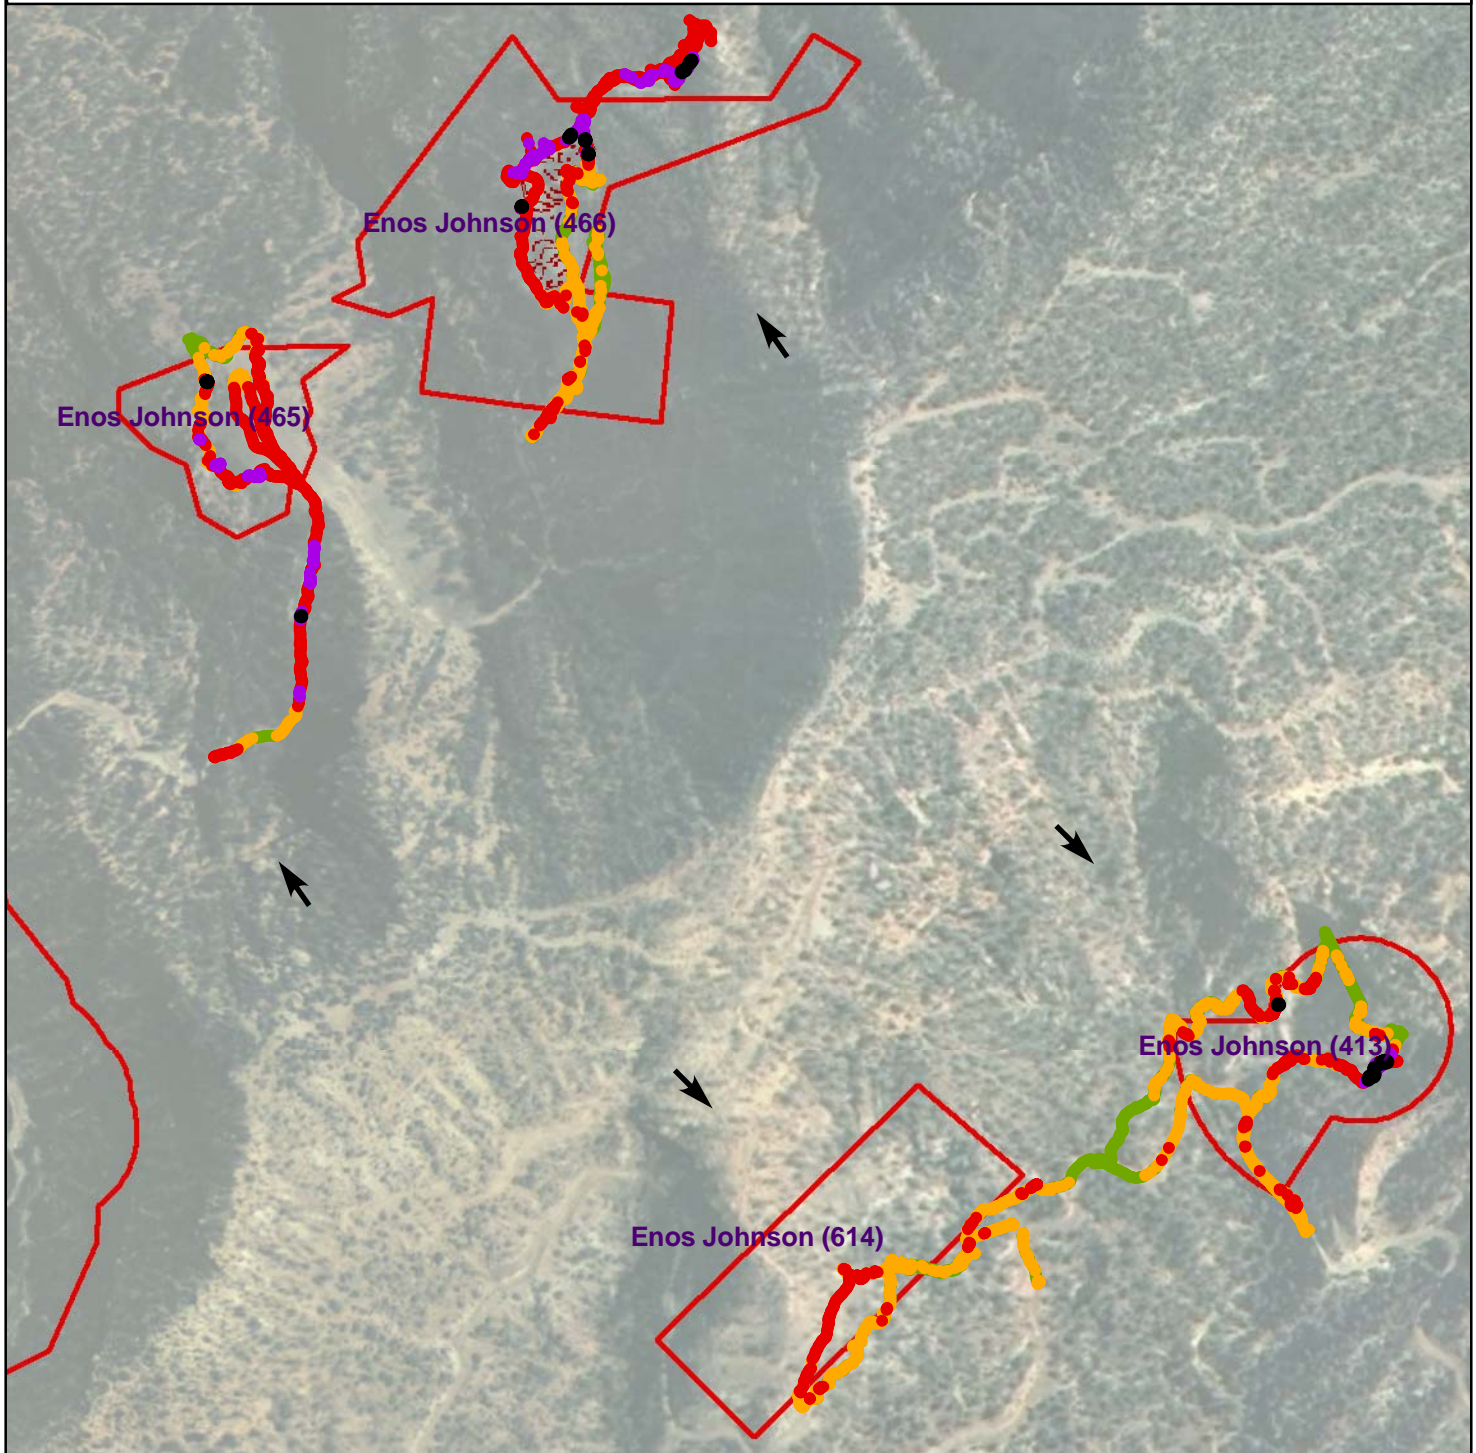
**Figure 1 - Gamma Radiation Measurements**  
**Enos Johnson (413, 465, 614)**  
**Navajo Nation, Arizona**

Gamma survey conducted 10/2009  
 Measured as counts per minute (cpm)

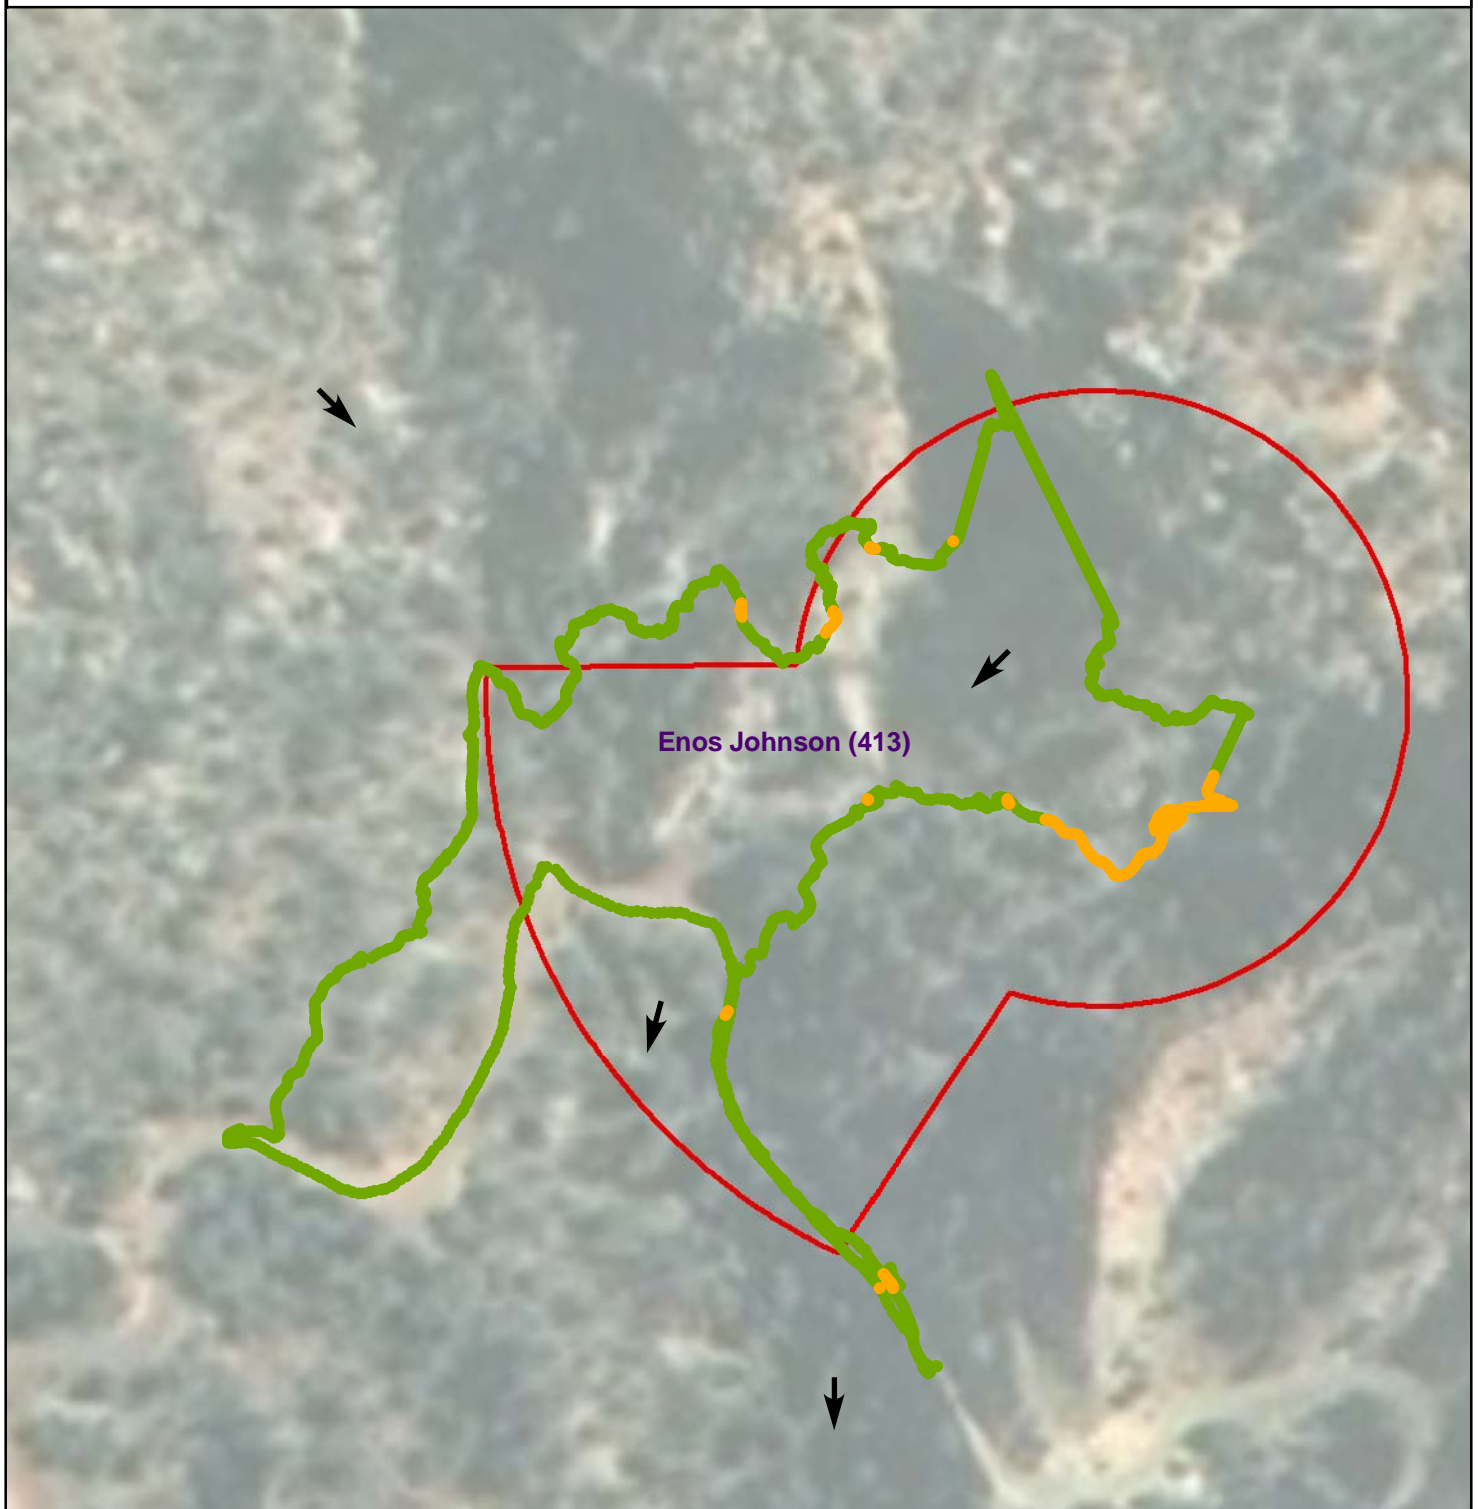
A total of 2,878 gamma radiation measurements were collected from the mine site, ranging from 7,668 cpm to 313,866 cpm. The measurements are represented in Figures 2 and 3.

**Figure 2 - Gamma Radiation Measurements, Above Two Times Background  
Enos Johnson (413)  
Sanostee Chapter, Navajo Nation, Arizona**

Average background = 13,037 cpm

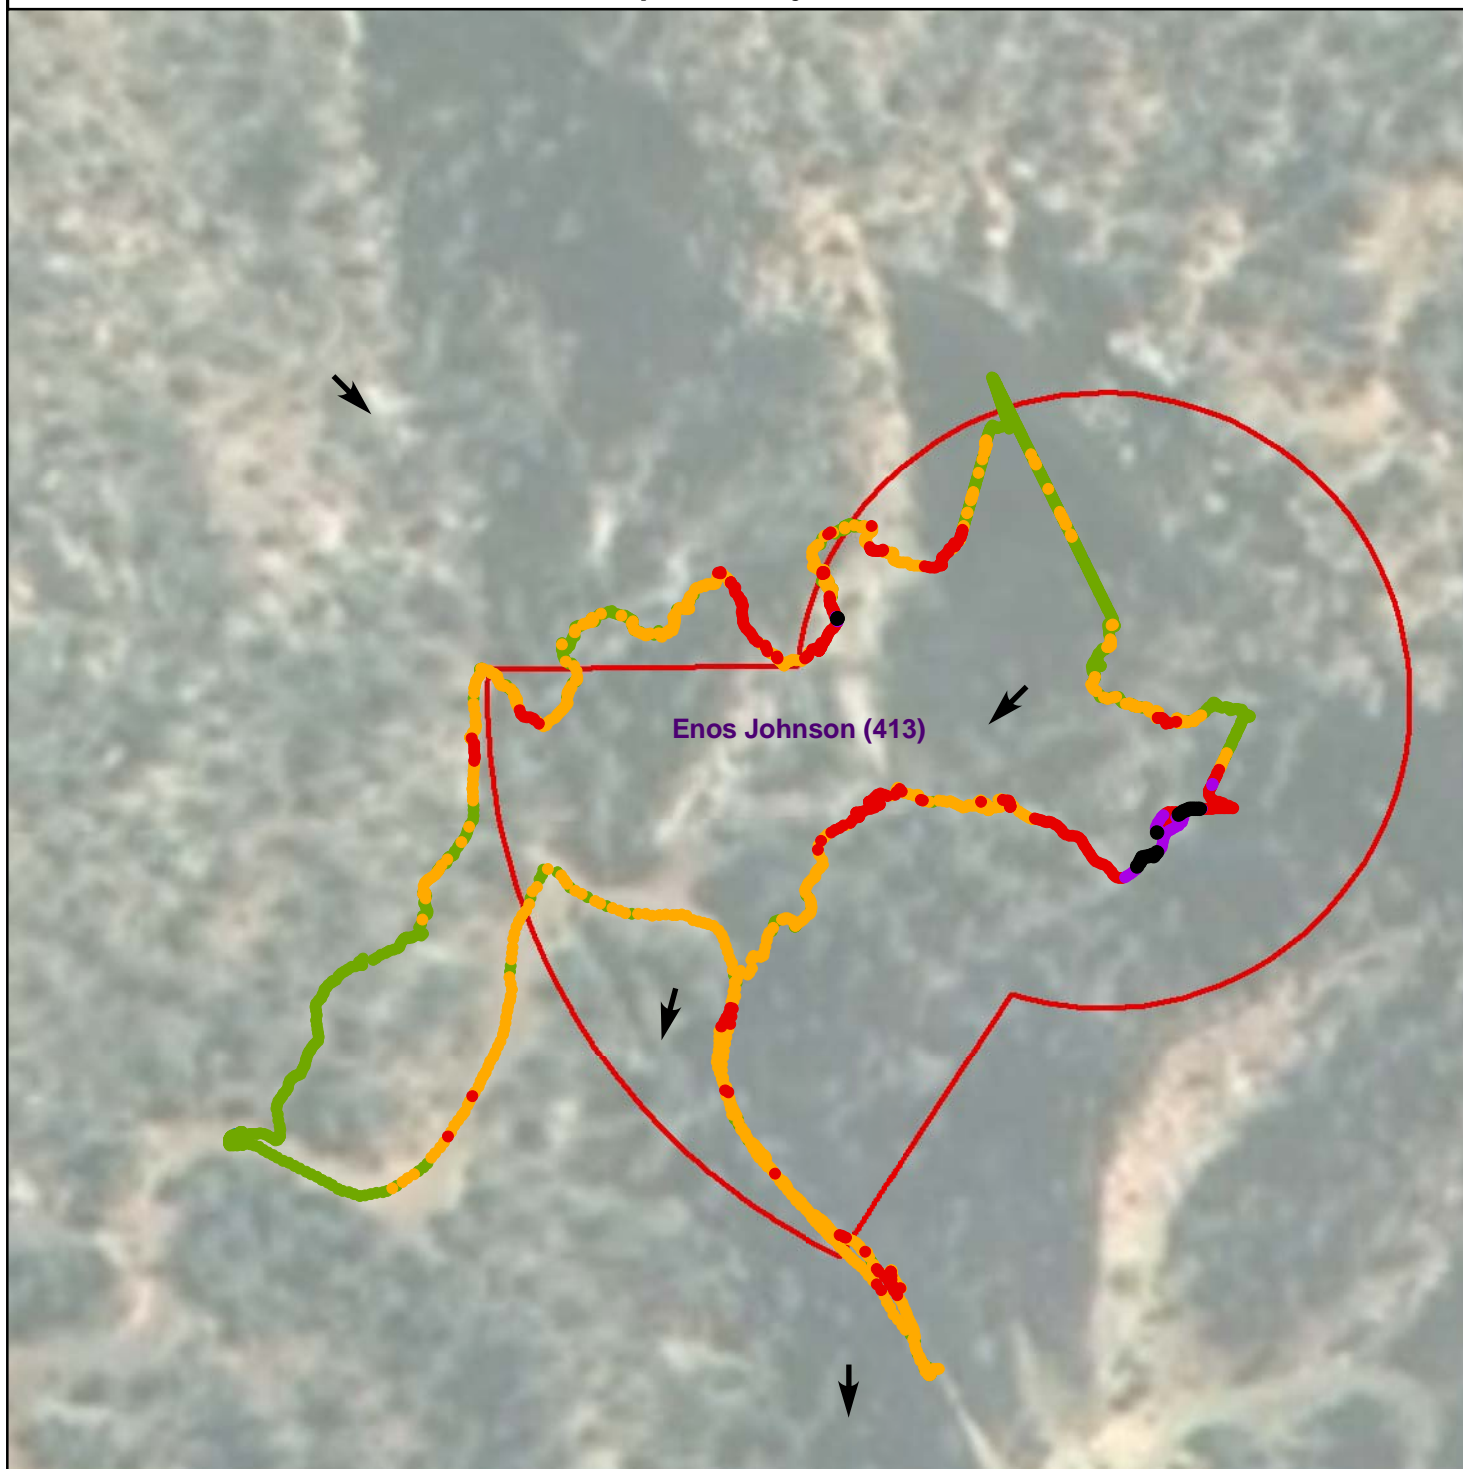
**Figure 3 - Gamma Radiation Measurements**  
**Enos Johnson (413)**  
**Sanostee Chapter, Navajo Nation, Arizona**

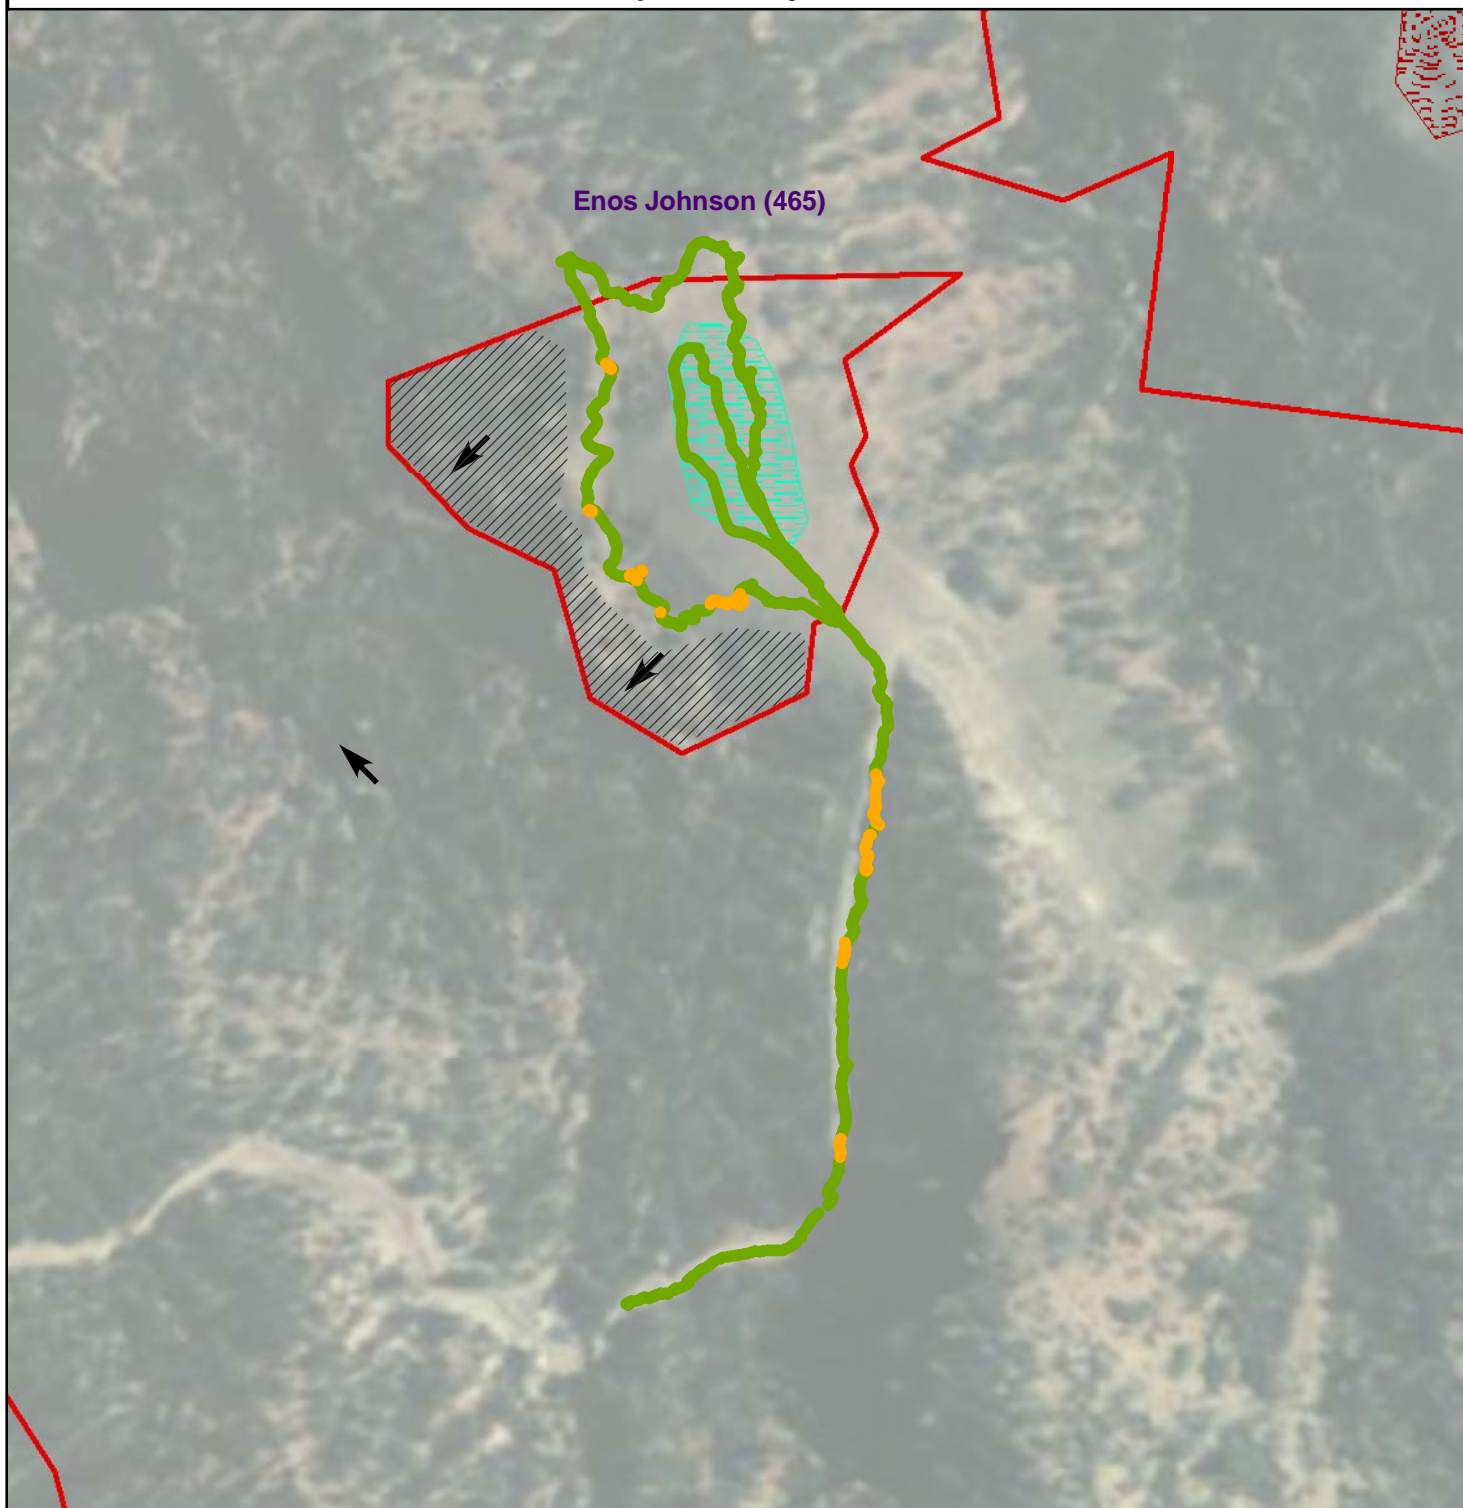
**Figure 4 - Gamma Radiation Measurements, Above Two Times Background  
Enos Johnson (465)  
Sanostee Chapter, Navajo Nation, Arizona**

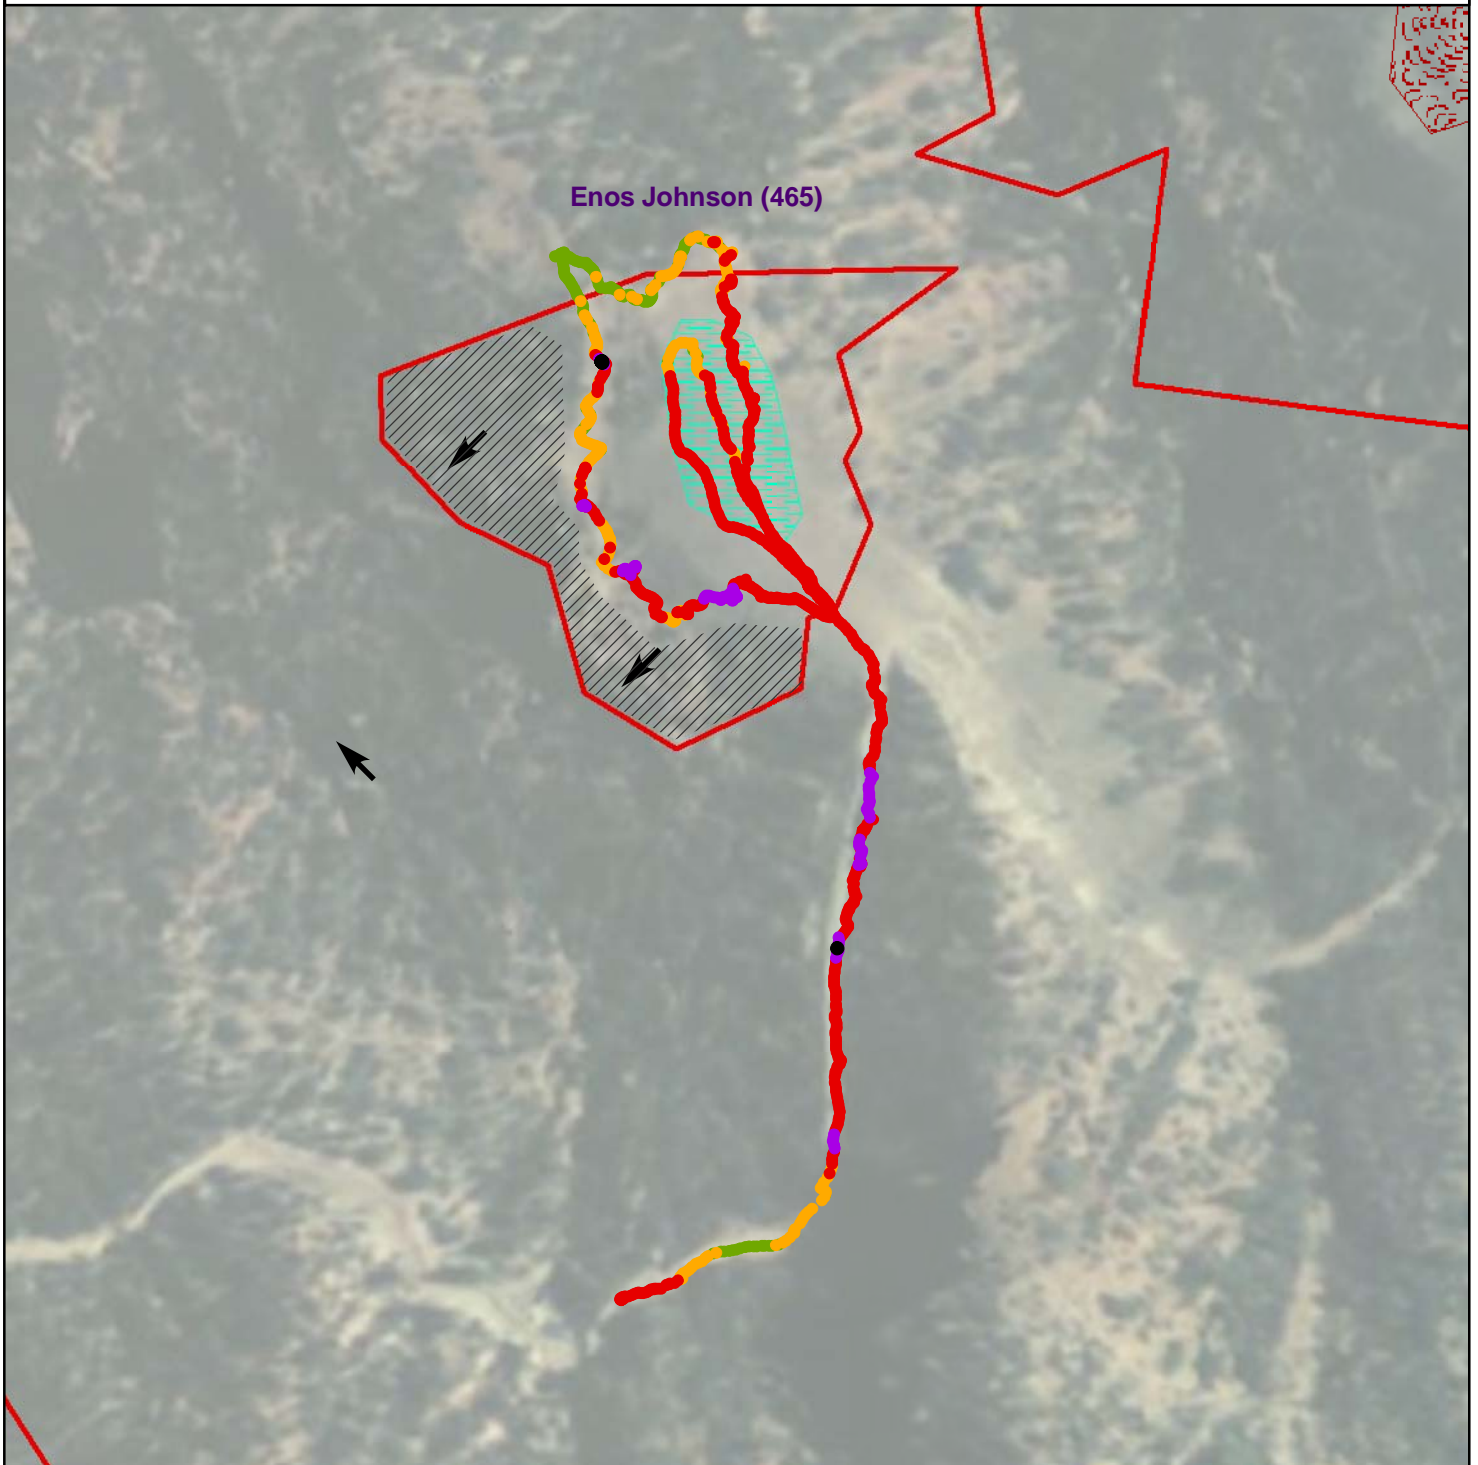
**Figure 5 - Gamma Radiation Measurements  
Enos Johnson (465)  
Sanostee Chapter, Navajo Nation, Arizona**

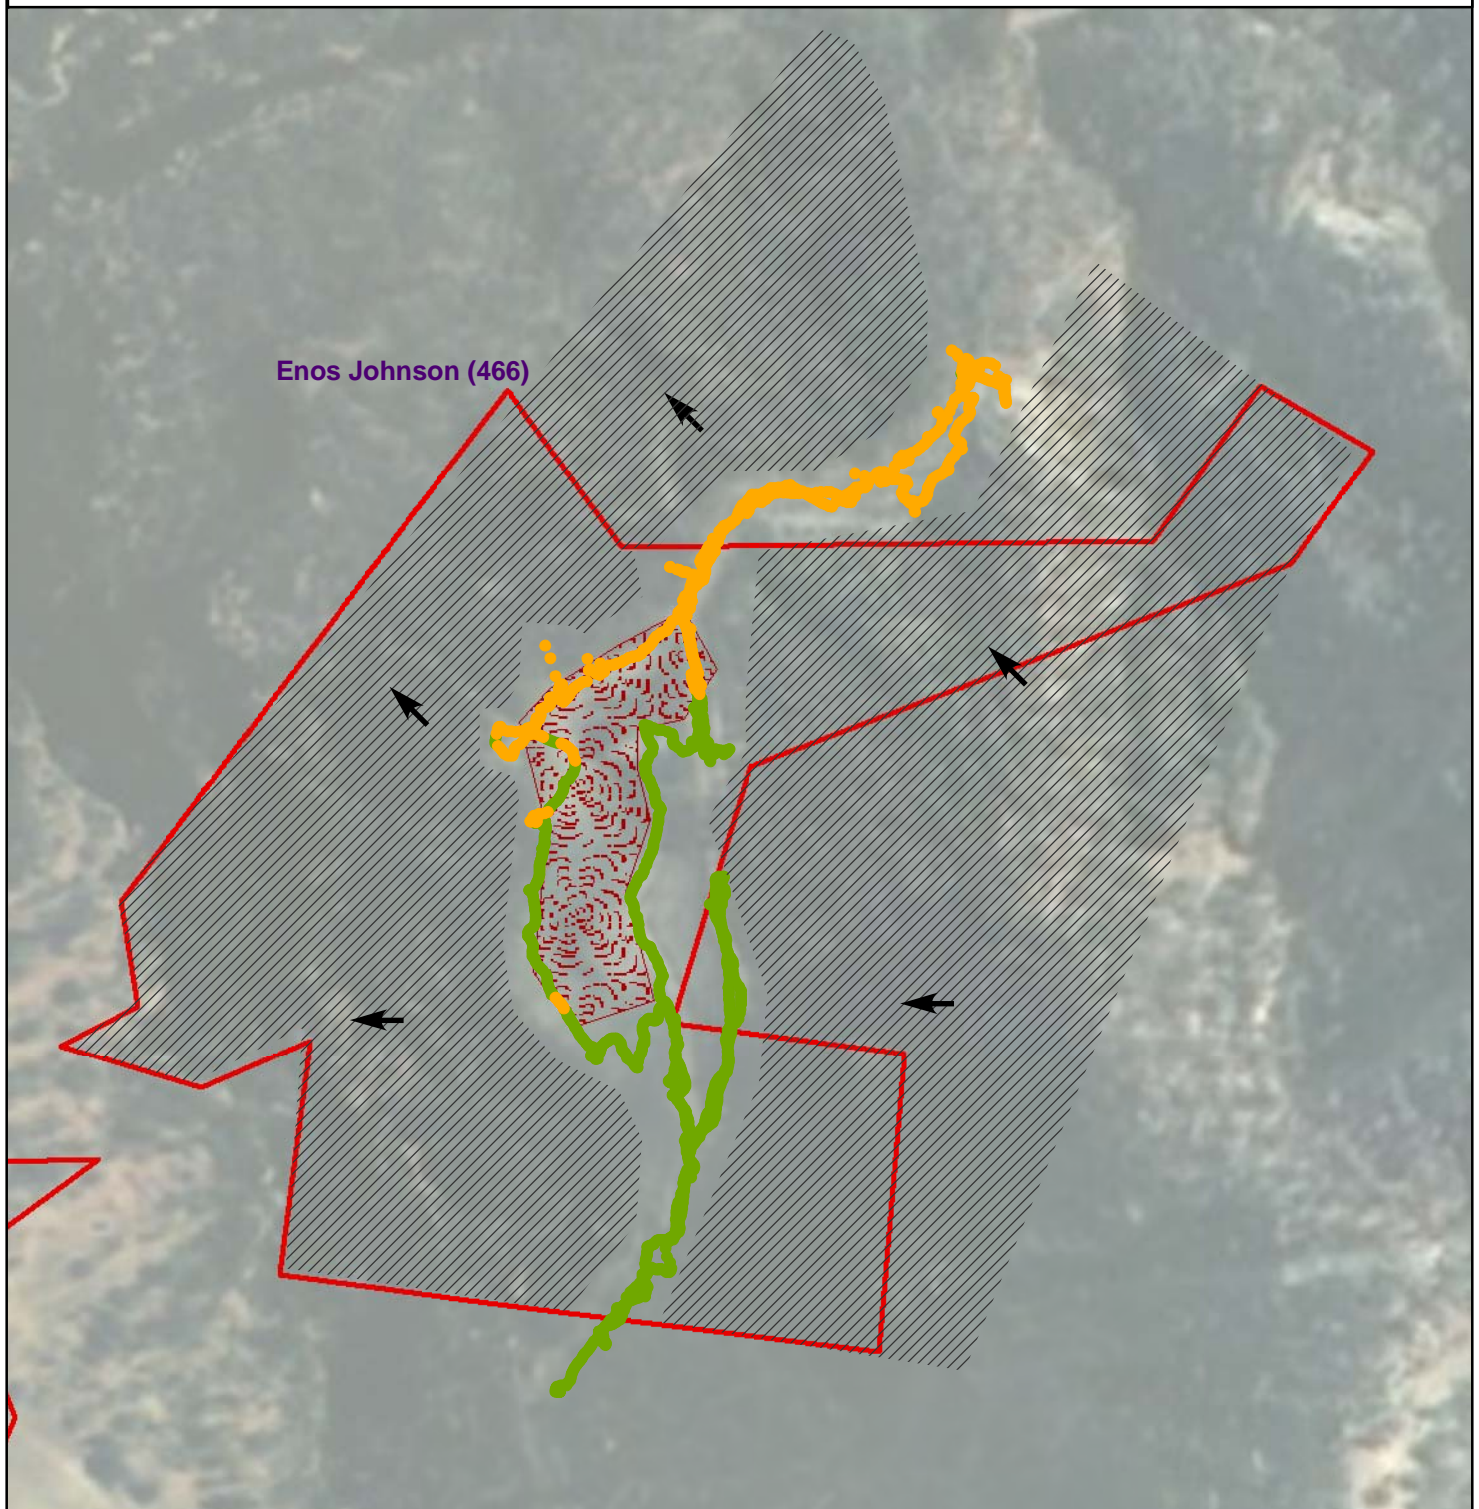
**Figure 6 - Gamma Radiation Measurements, Above Two Times Background  
Enos Johnson (466)  
Sanostee Chapter, Navajo Nation, Arizona**

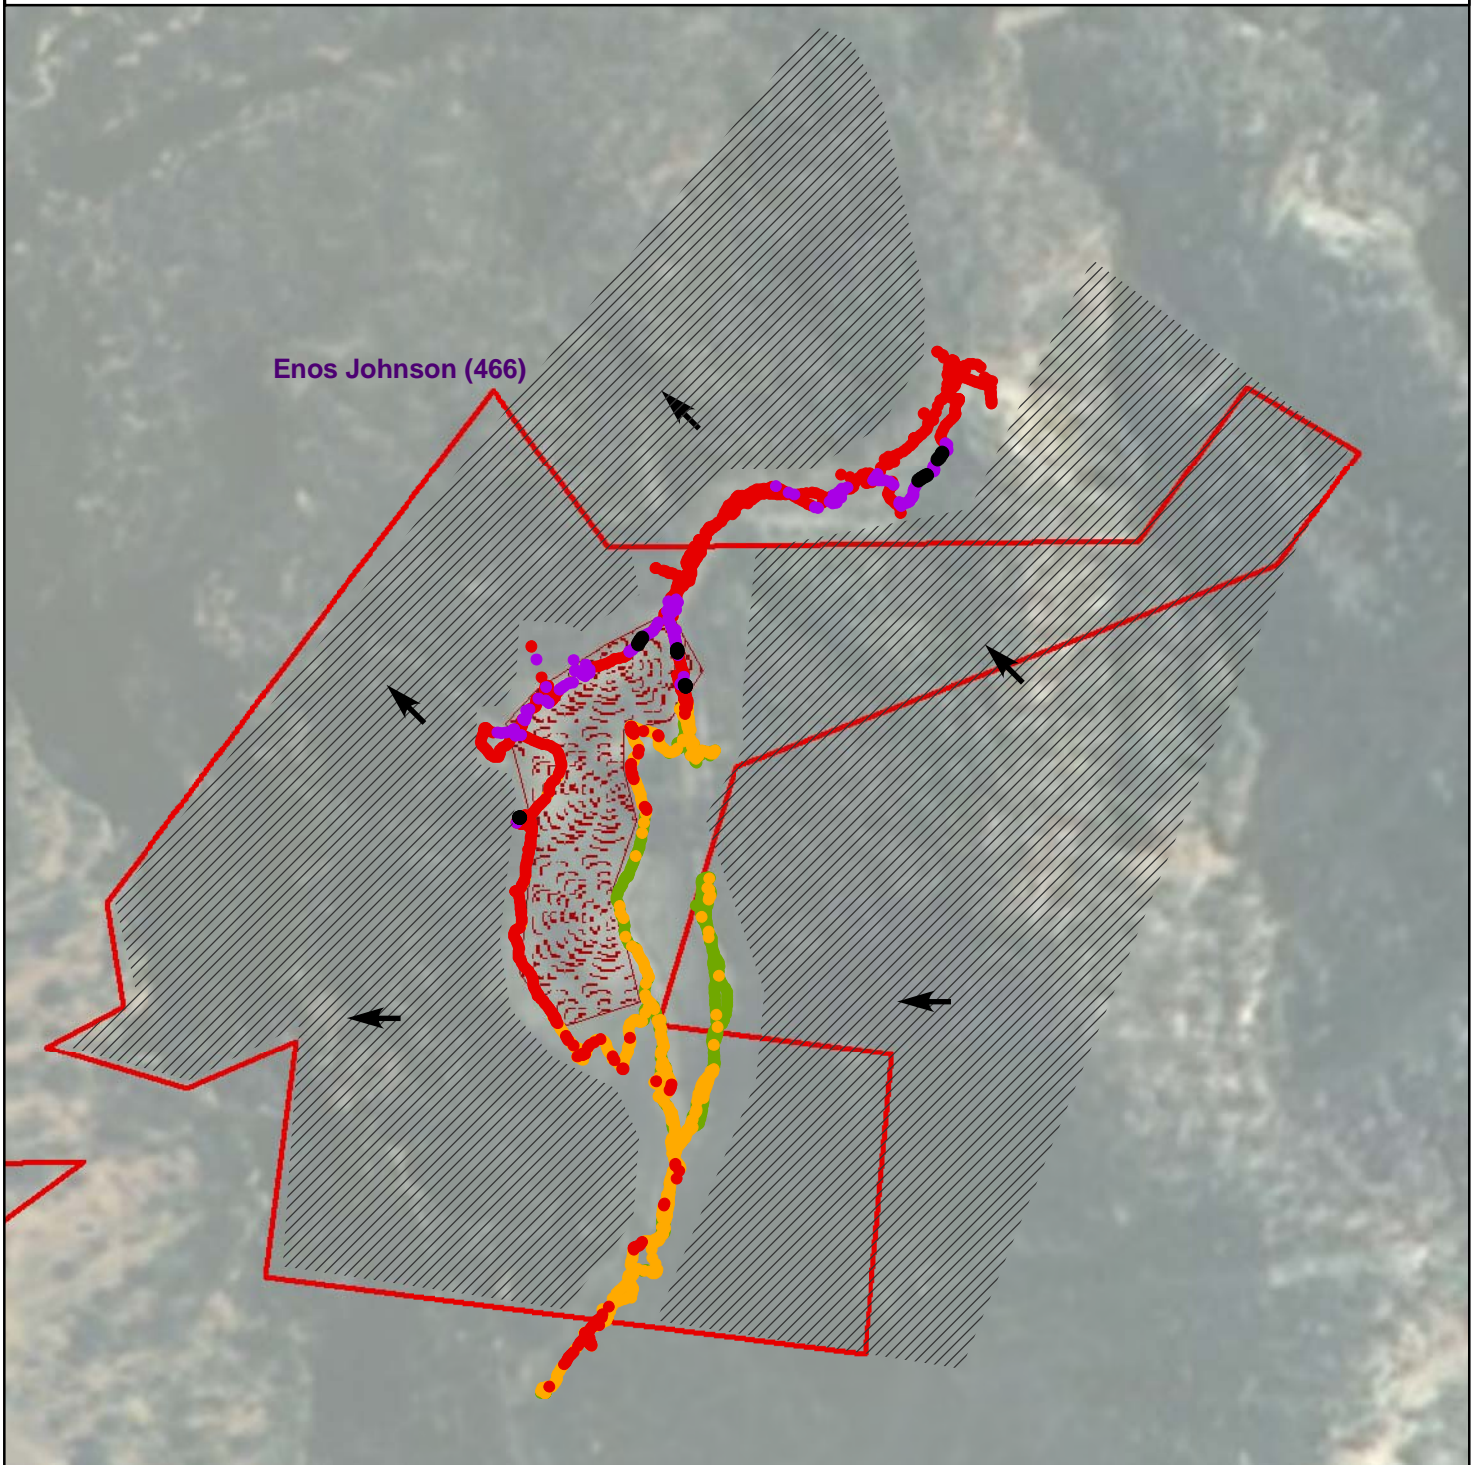
**Figure 7 - Gamma Radiation Measurements**  
**Enos Johnson (466)**  
**Sanostee Chapter, Navajo Nation, Arizona**
